Rifton Equipment

URGENT: MEDICAL DEVICE CORRECTION

K310 & K320 Rifton TRAM

K660 E-Pacer

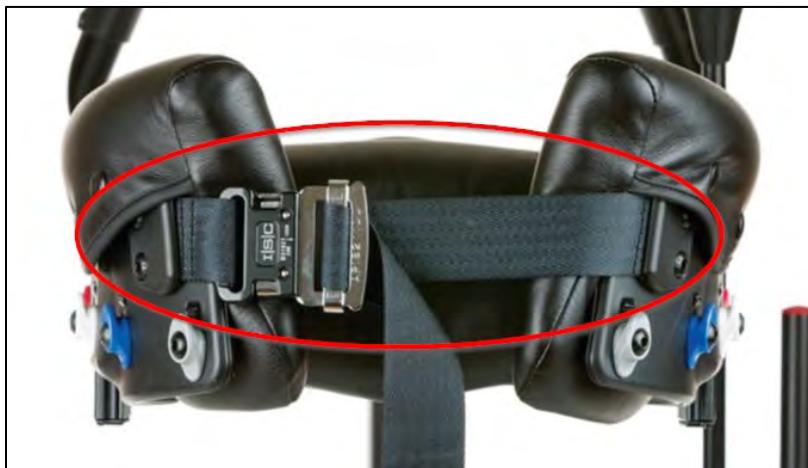
The Body Support Strap is sewn at both ends to an aluminum stamping which is secured to the body support. Some of these stampings were manufactured with edges that are slightly sharper than normal, and over time these sharper edges can abrade the strap material, causing the strap to fray and eventually break.

Inspect your TRAM or E-Pacer by pulling down on the body support strap and checking, on both ends, to see if any fraying is visible. If no fraying is visible, you may temporarily continue to use the device until the replacement kit arrives. If fraying is visible on either end of the strap, please discontinue use of your TRAM or E-Pacer immediately until the body support is replaced.

The person responsible for performing the replacement will need to remove and discard the old body support and install the new one with the tools and hardware provided. We will need confirmation from you when the replacement has been done.

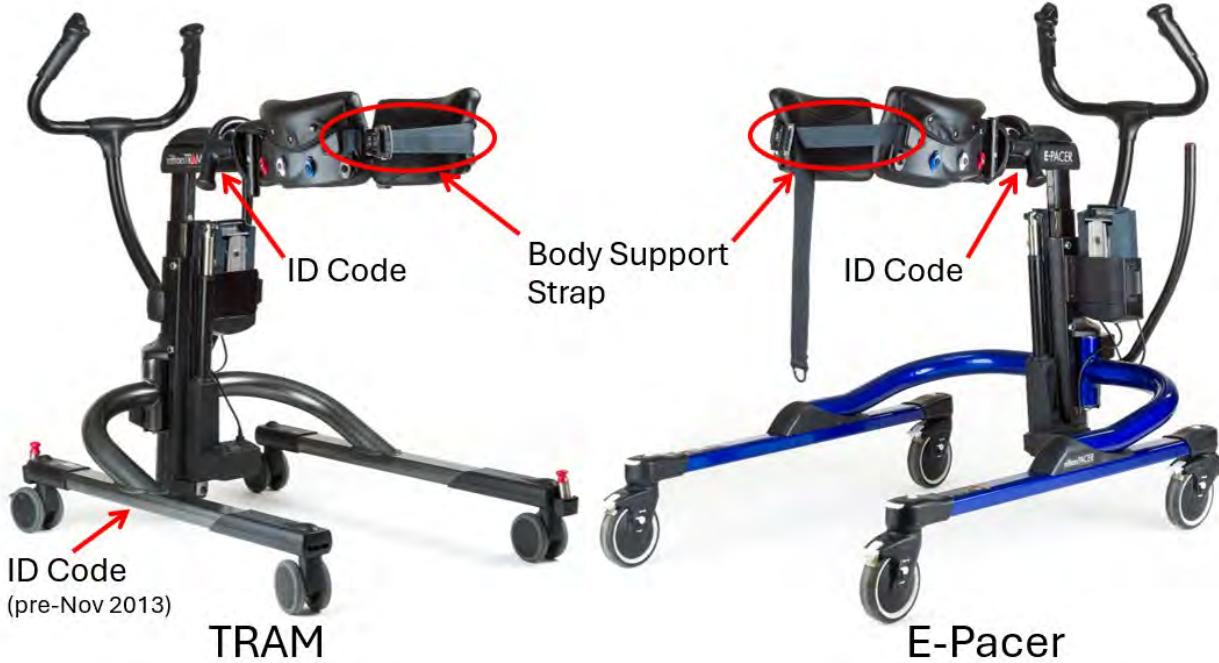
The ID code can be found either under the horizontal mast, right below the "Rifton TRAM" or "E-Pacer" label, or for TRAMs ordered prior to November 2013, under the left leg:

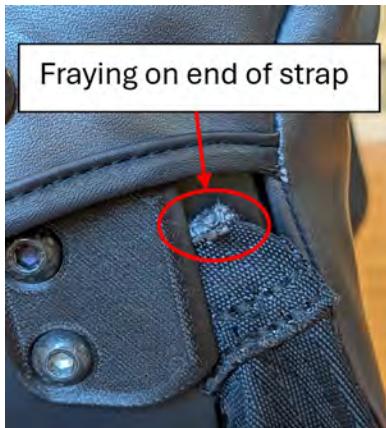
An example of a fraying strap
